# ENVIRONMENTAL PROBING INVESTIGATIONS, INC.

## SUBSURFACE SURVEY REPORT

Environmental Probing Investigations, Inc. (EPI) was contracted by . . . . to locate utilities and investigate areas of concern surrounding a bus service building.

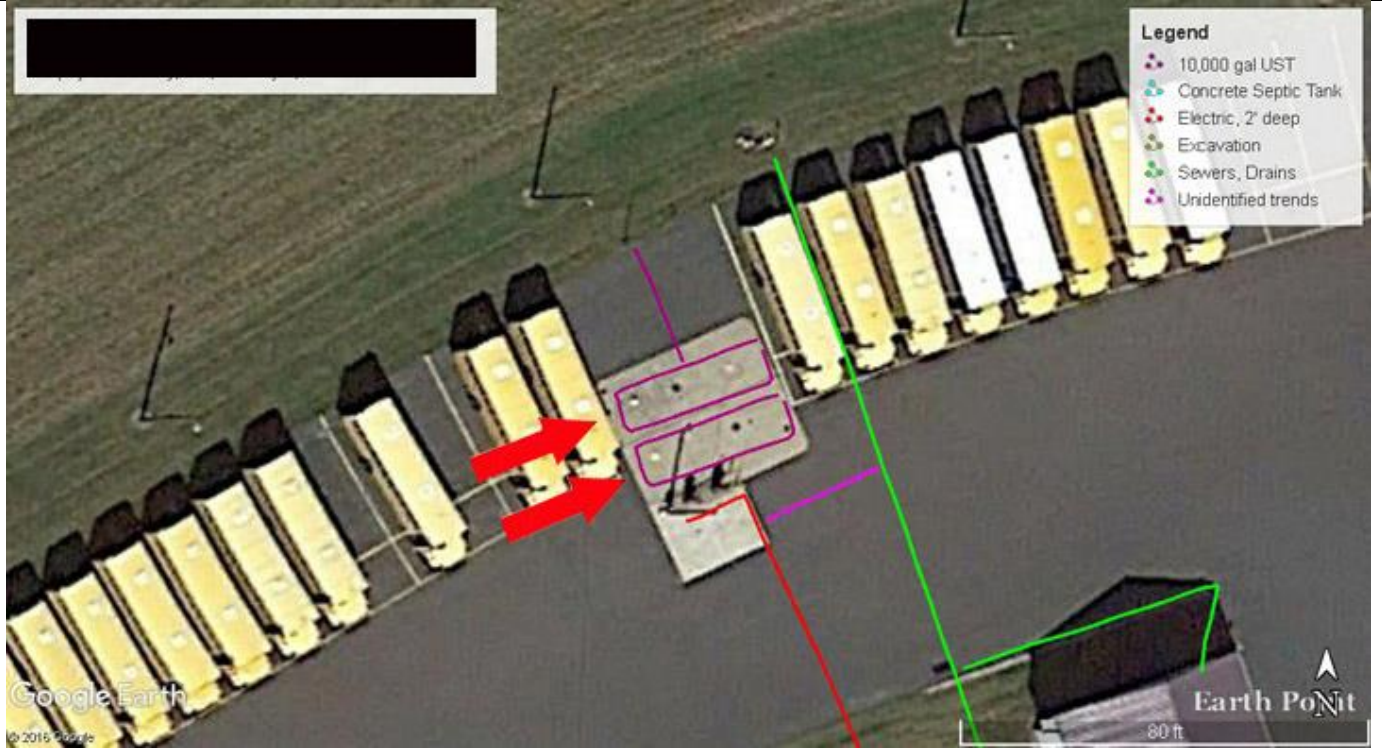
PHOTO 1

The arrows point to the two 10,000 gallon USTs which measure 27' long and 8' wide. A pair of vent pipes sits at the contact between the asphalt and the grass. Electric power to the fuel island is shown in red and arrives via a buried line from the building.

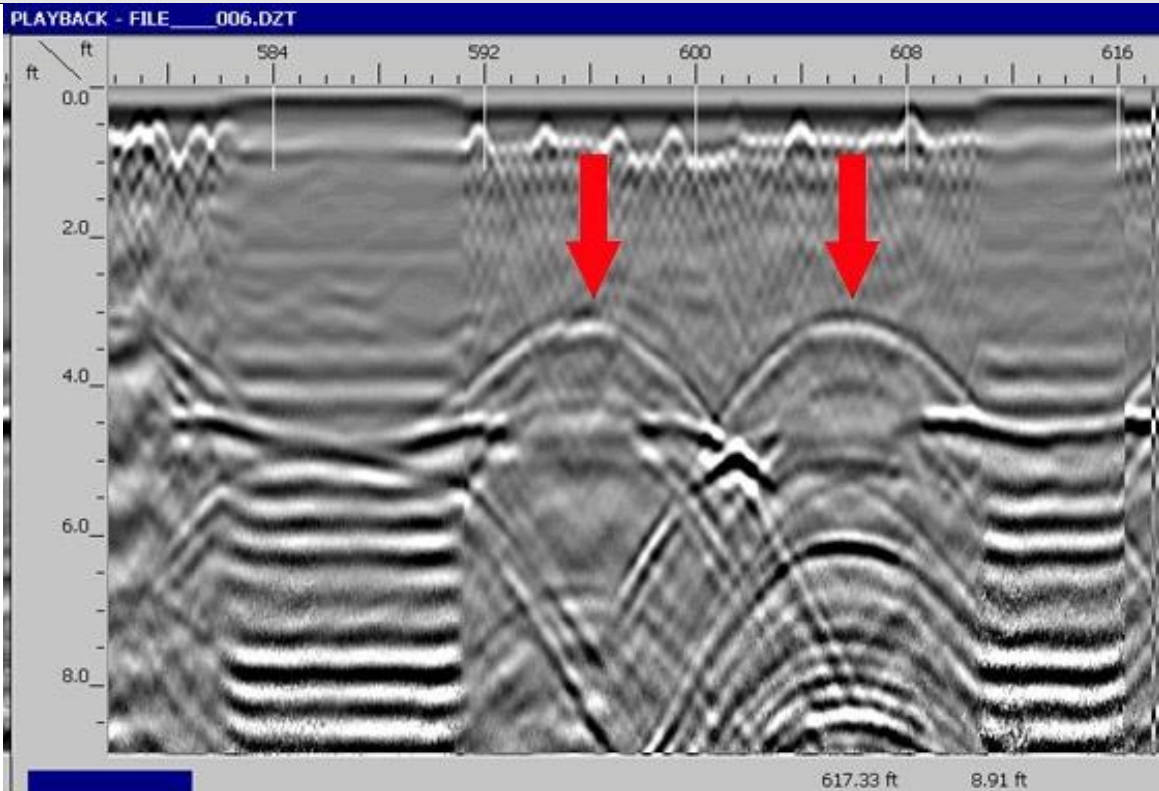
PHOTO 2

GPR transect across the two USTs shows that the tops of those tanks sit at a depth of 3' below surface.

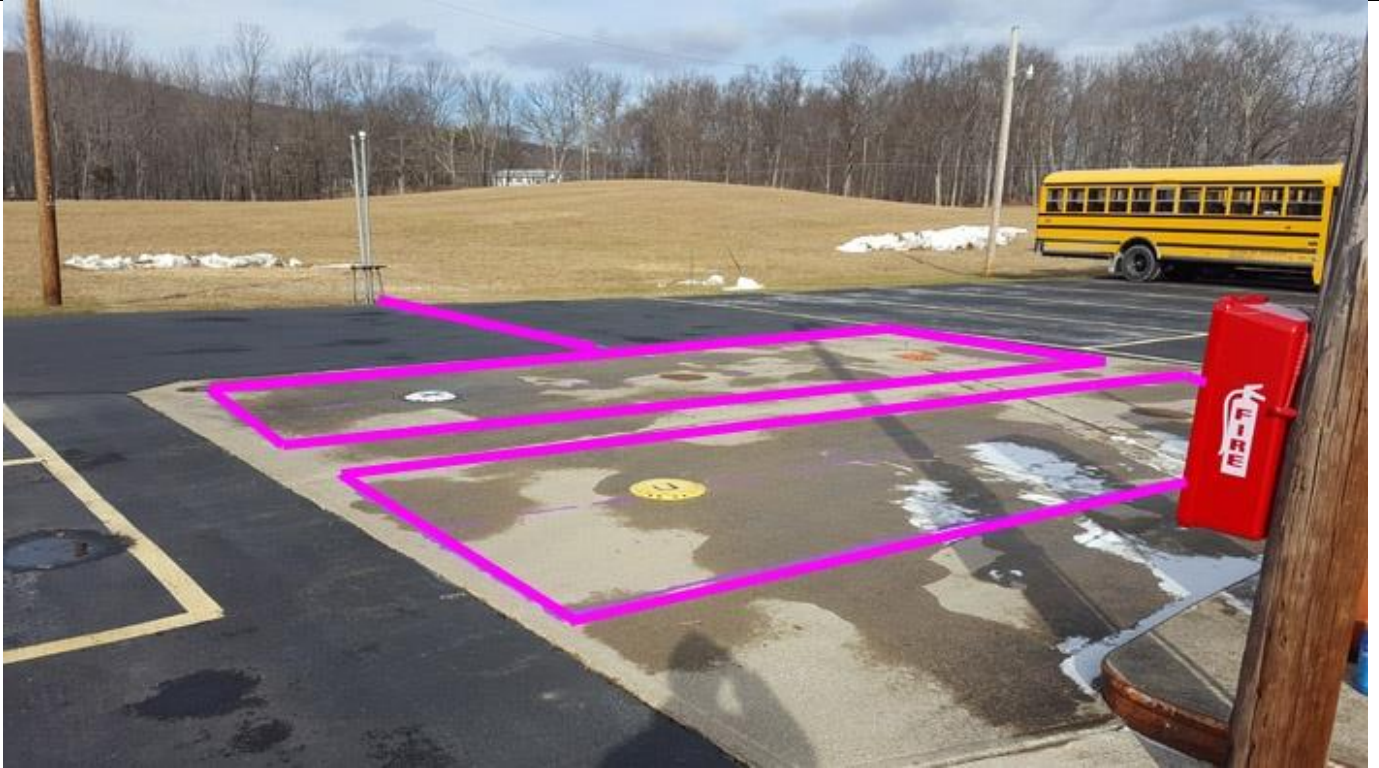
**PHOTO 3**

Northeast facing photo shows the outlines of the two 10,000 gallon USTs. The tanks each measure 27' x 8'. The vent pipe is visible behind an perpendicular to the tanks.

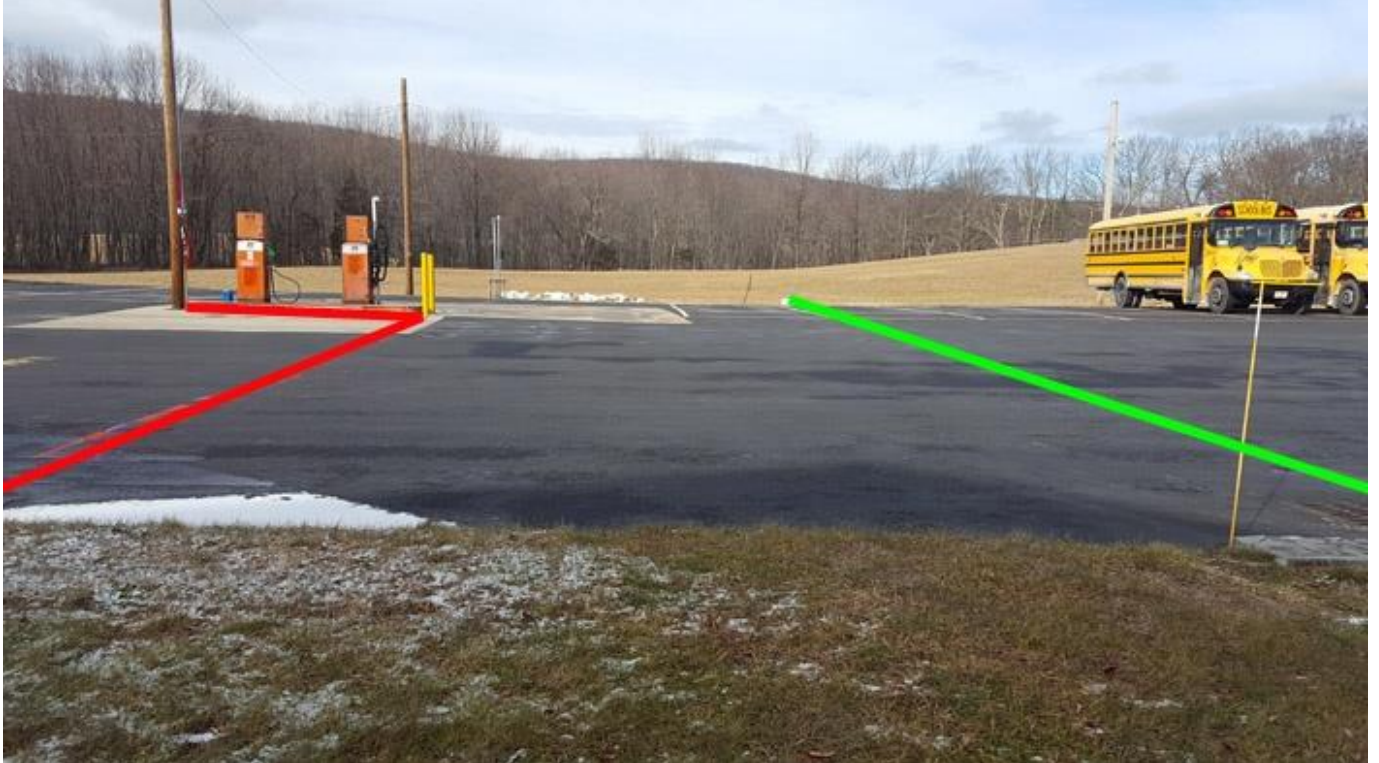
**PHOTO 4**

Northwest facing photo of the fueling island area as seen from near the building shows the electric line in red and a storm sewer in green.

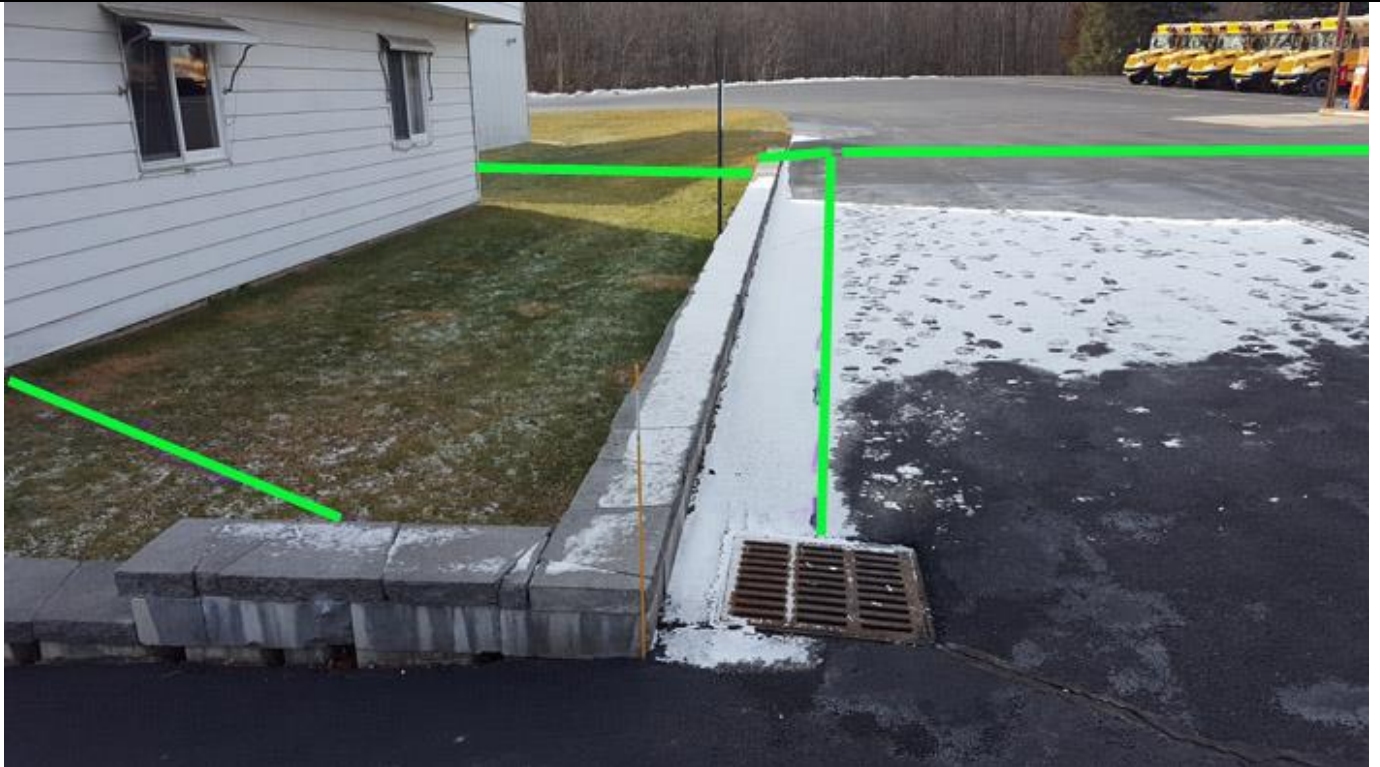
PHOTO 5

Southwest facing photo shows a series of storm sewers and drains in green.

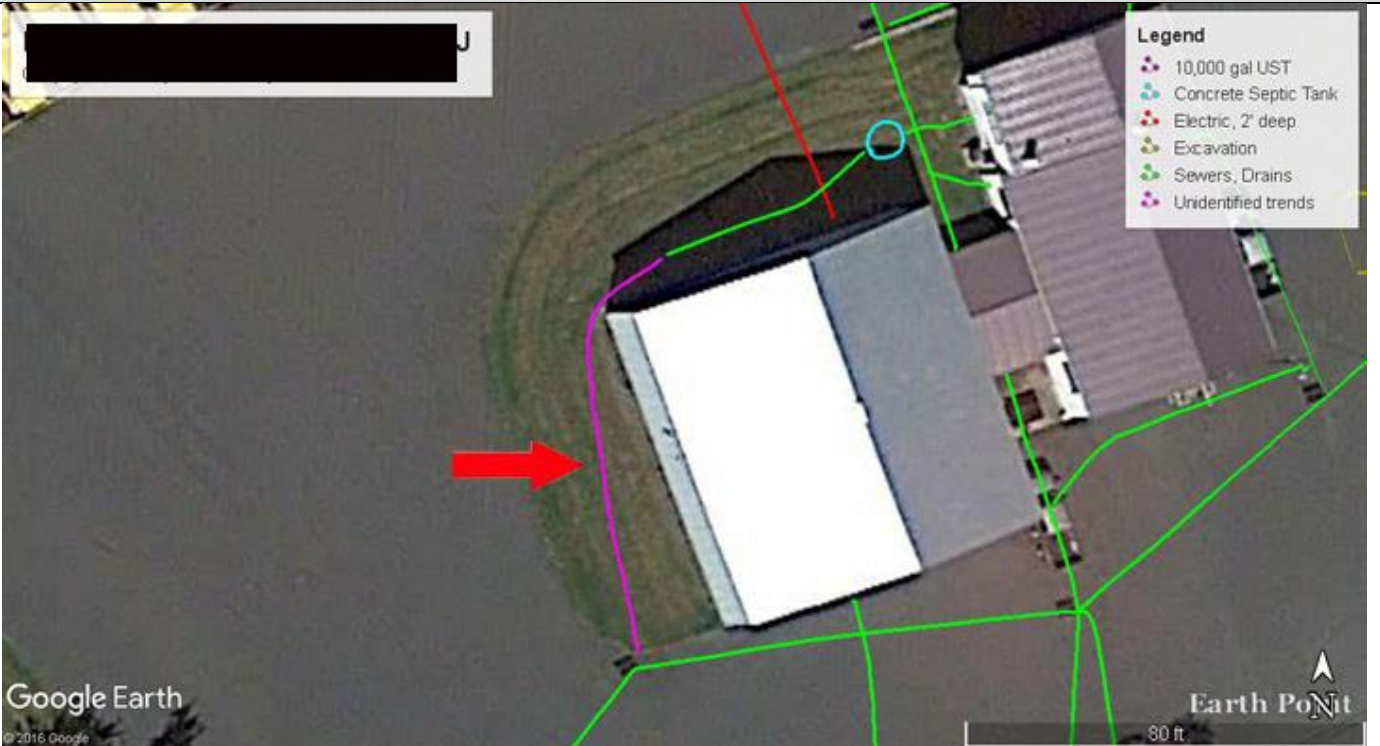
PHOTO 6

Sewer and drains surround the bus service building. The circle near the northeast corner of the building is a concrete septic tank, and the green line to the west of the septic tank is a PVC lateral. The purple line indicated by the arrow appears to be a gravel-filled trough allowing the filtered wastewater to drain into the storm sewer.

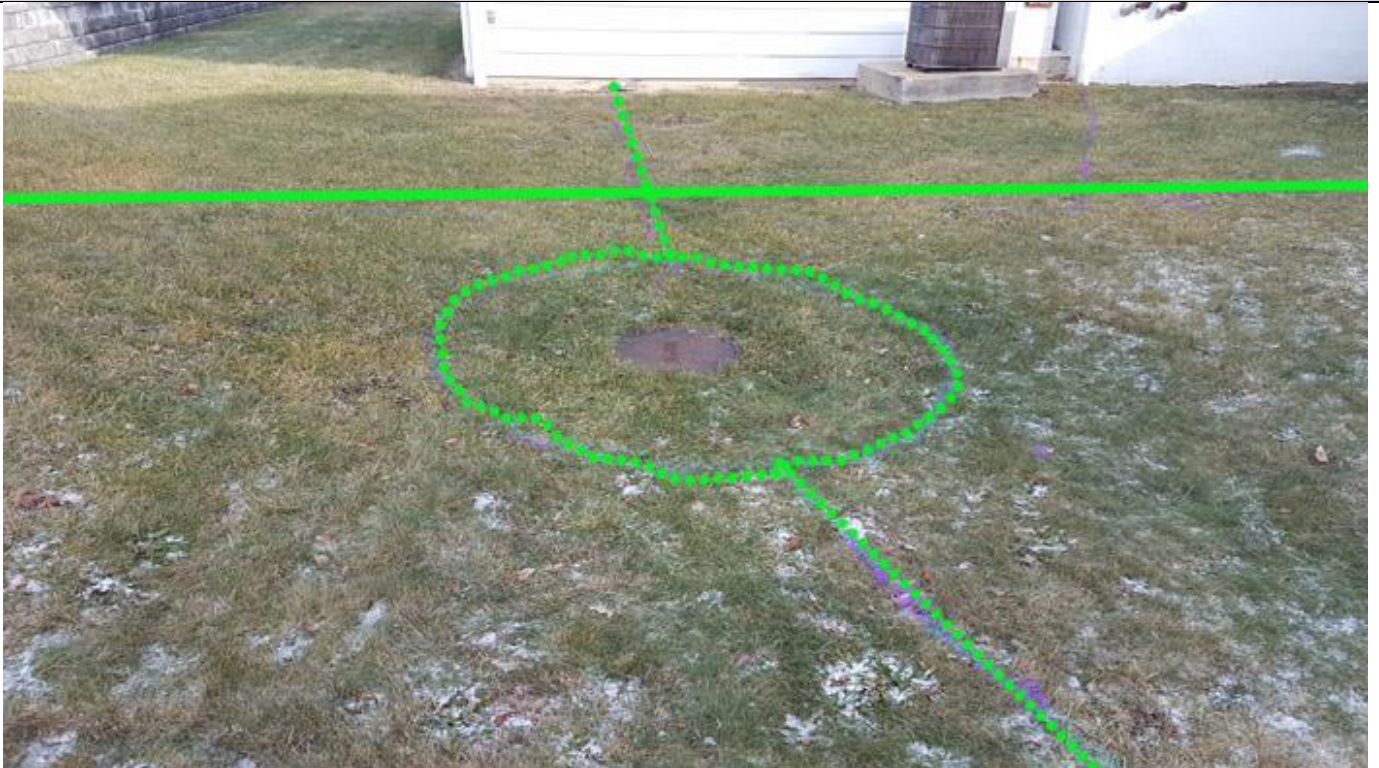
**PHOTO 7**

Northeast facing photo shows the circular concrete septic tank measuring around 6' in diameter. A sewer line conveys wastewater from the building to the tank. The lateral is in the foreground. The solid green line is a NW-SE trending storm sewer that goes beneath the building.

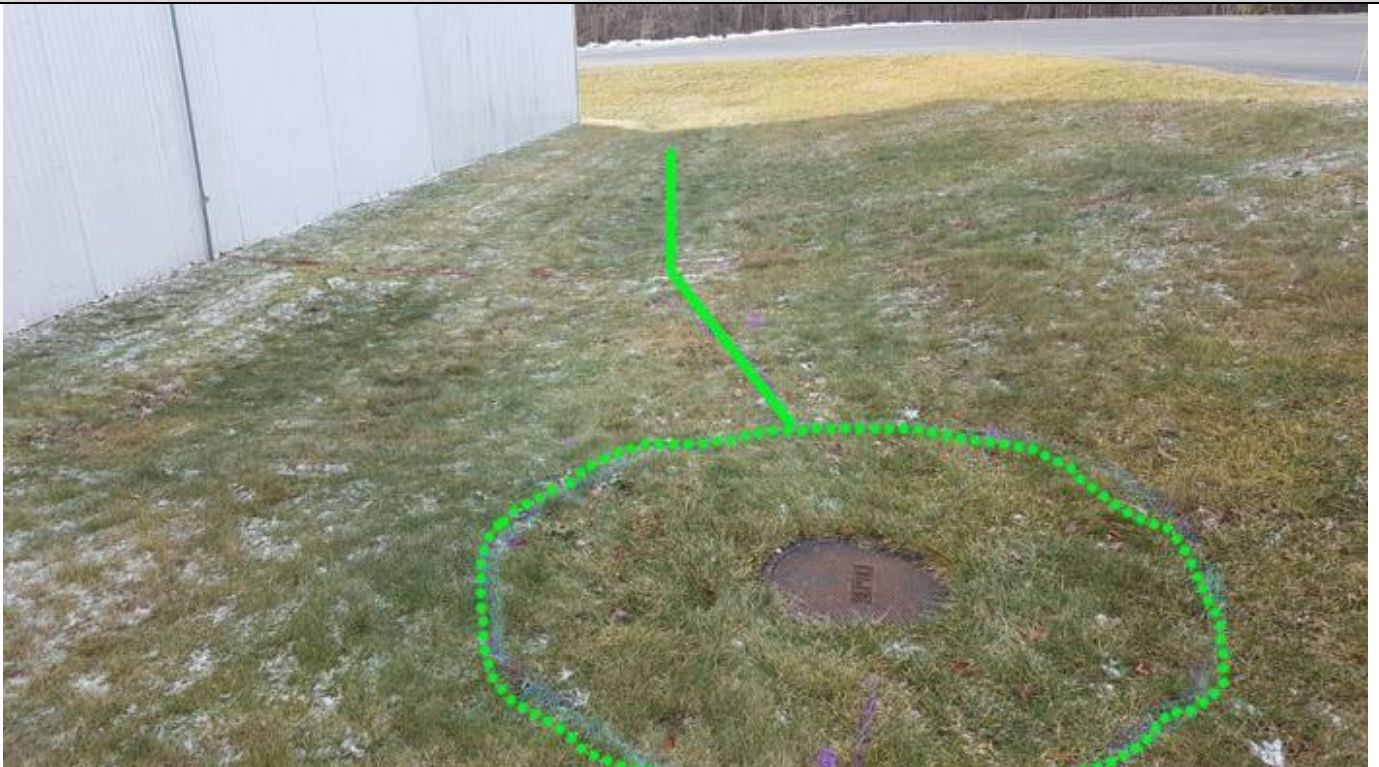
**PHOTO 8**

Southwest facing photo shows the circular concrete septic tank and the lateral PVC line that leads away from it. The lateral coincides with a topographic trough which is apparently filled with gravel.

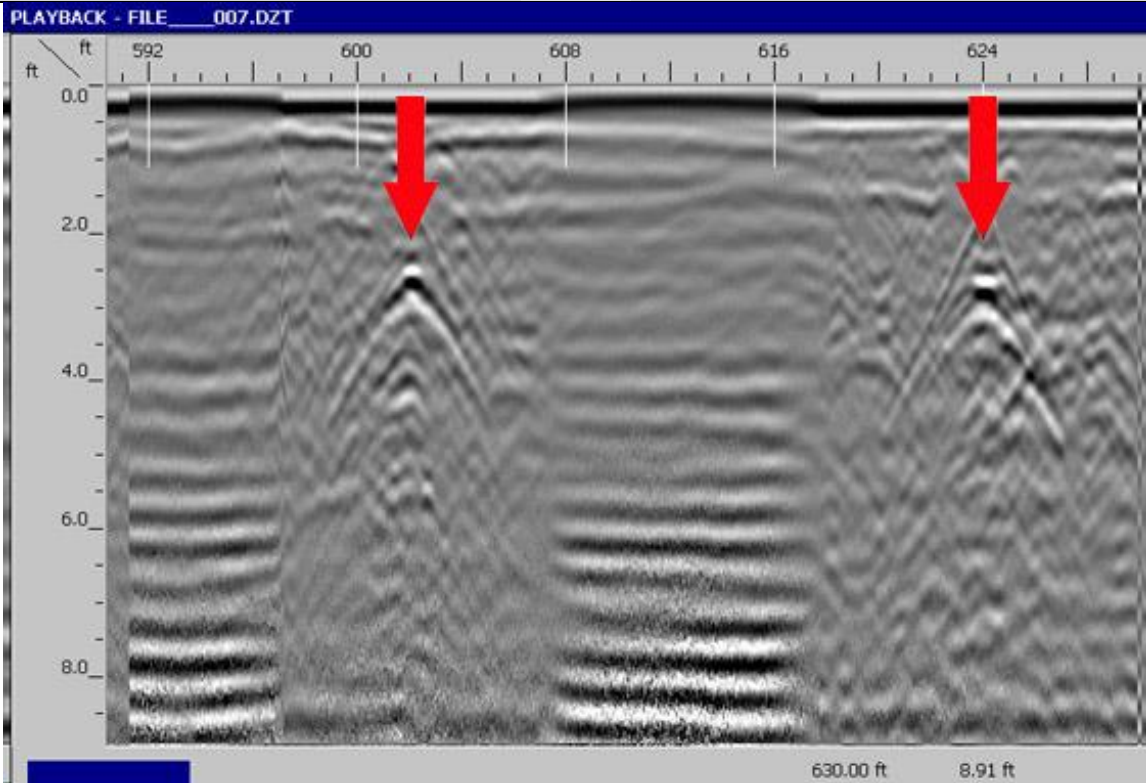
PHOTO 9

GPR transects across the PVC lateral shows that the lateral sits at a depth of around 3'.

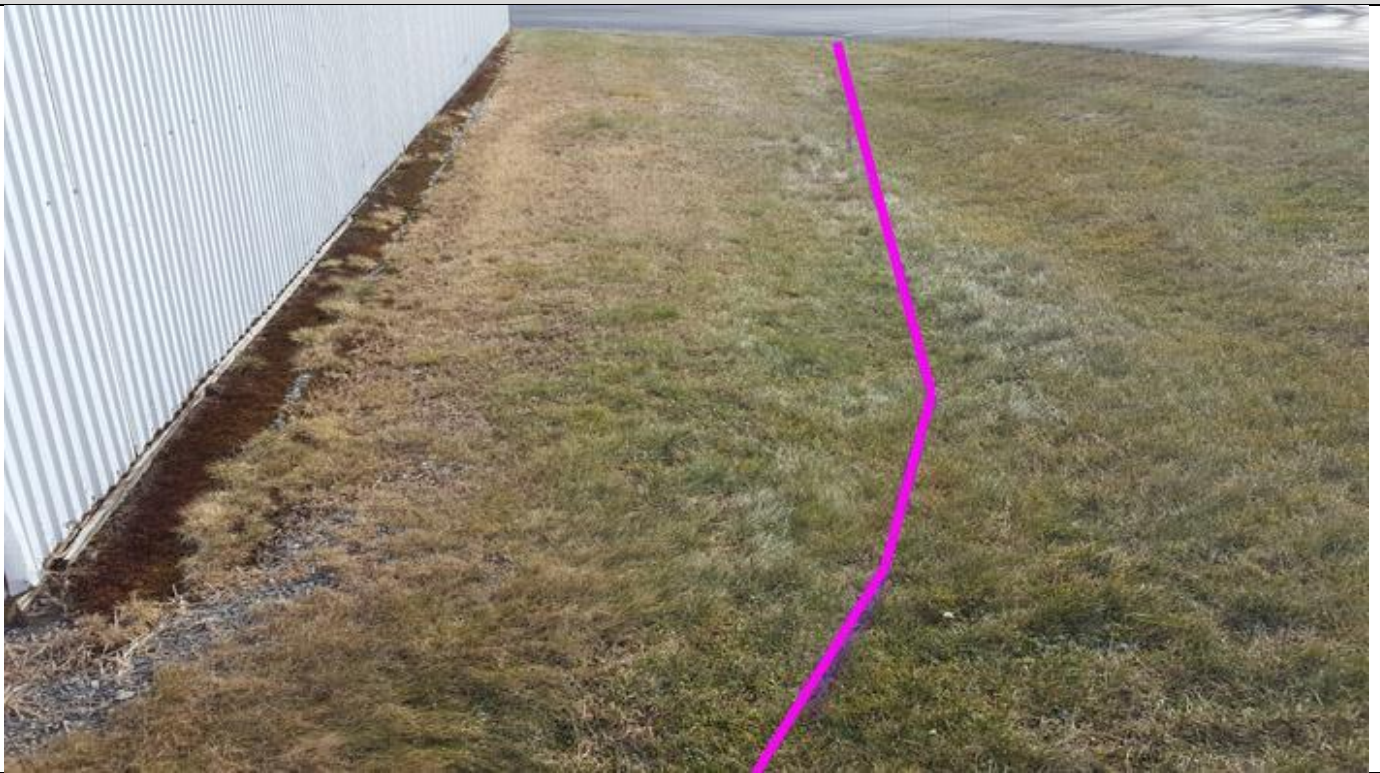
PHOTO 10

South facing photo shows the path of a zone which appears to be a gravel filled trough that conveys wastewater from the septic system to the storm drain in the distance.

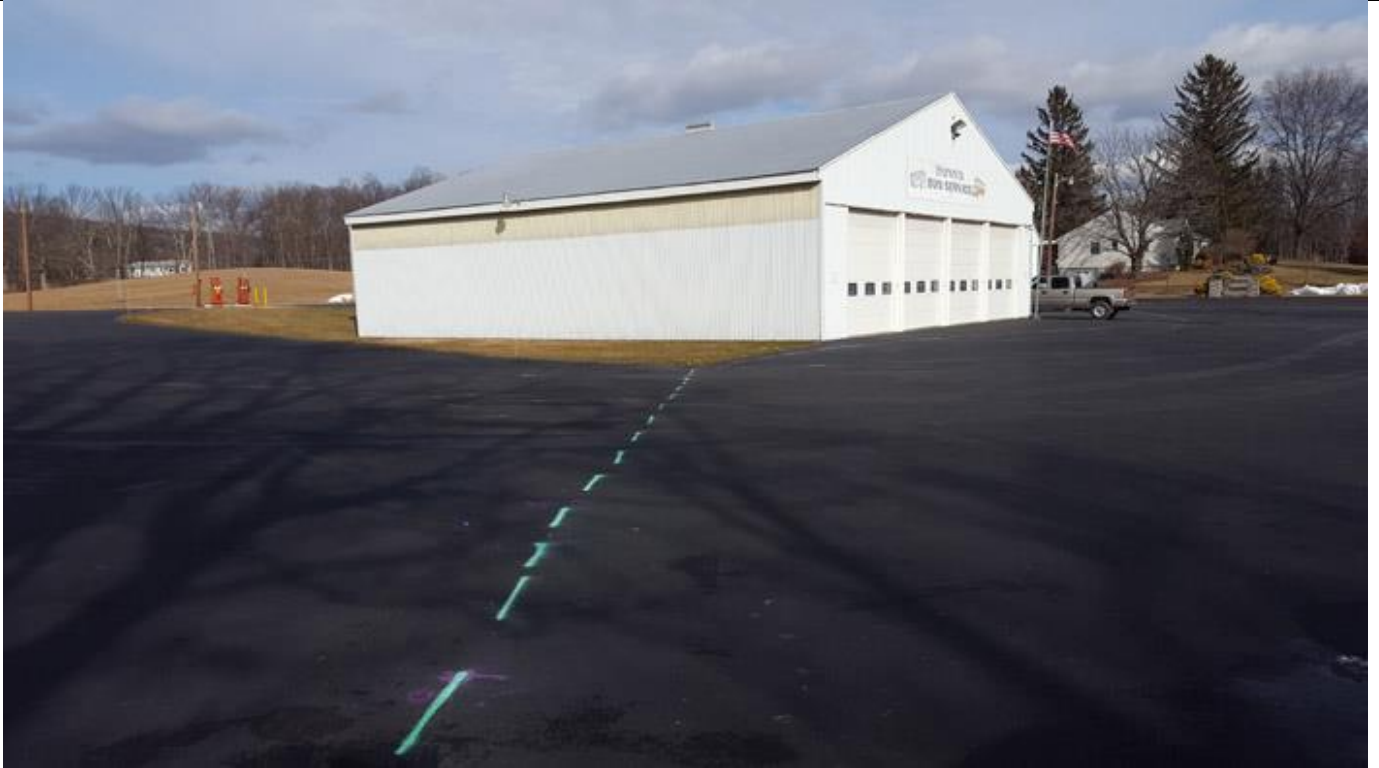
PHOTO 11

Northeast facing photo shows the storm sewer leading from the bus service building to a NW-SE trending creek on the west side of the property.

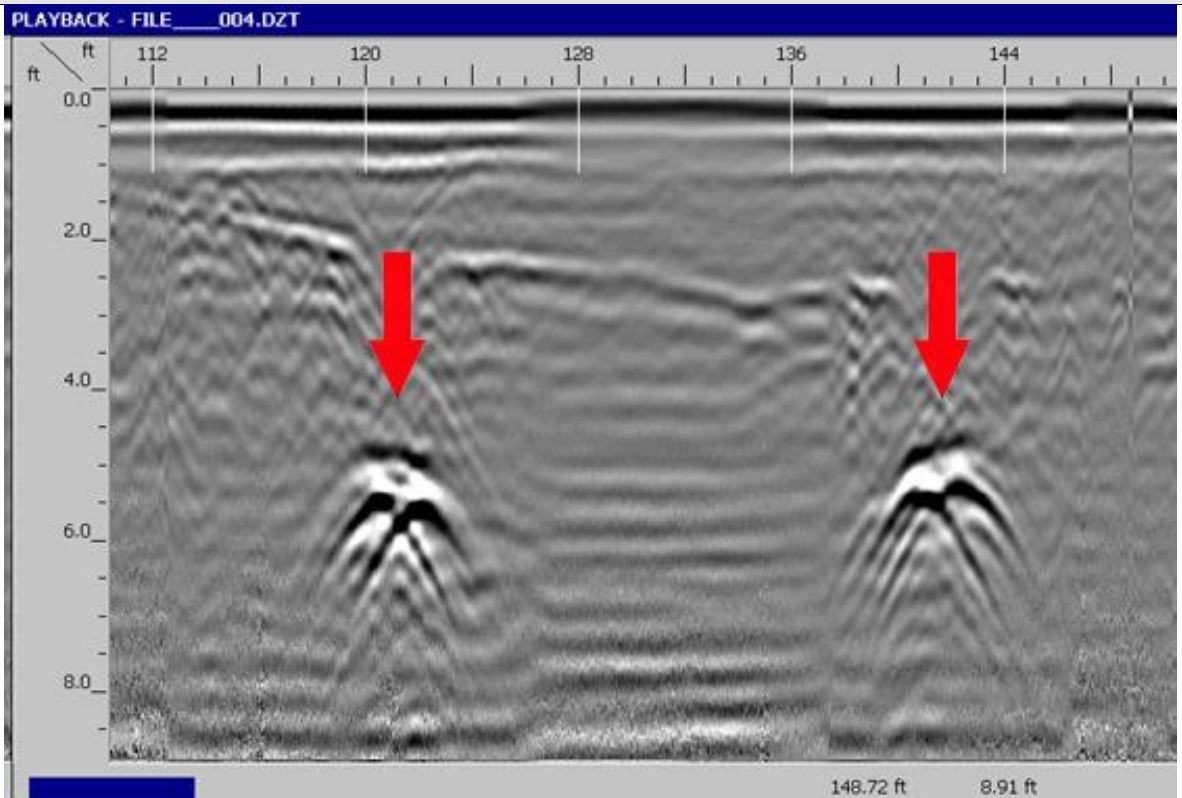
PHOTO 12

GPR transects across the storm sewer line in Photo 11 shows that it sits at a depth of around 5'.

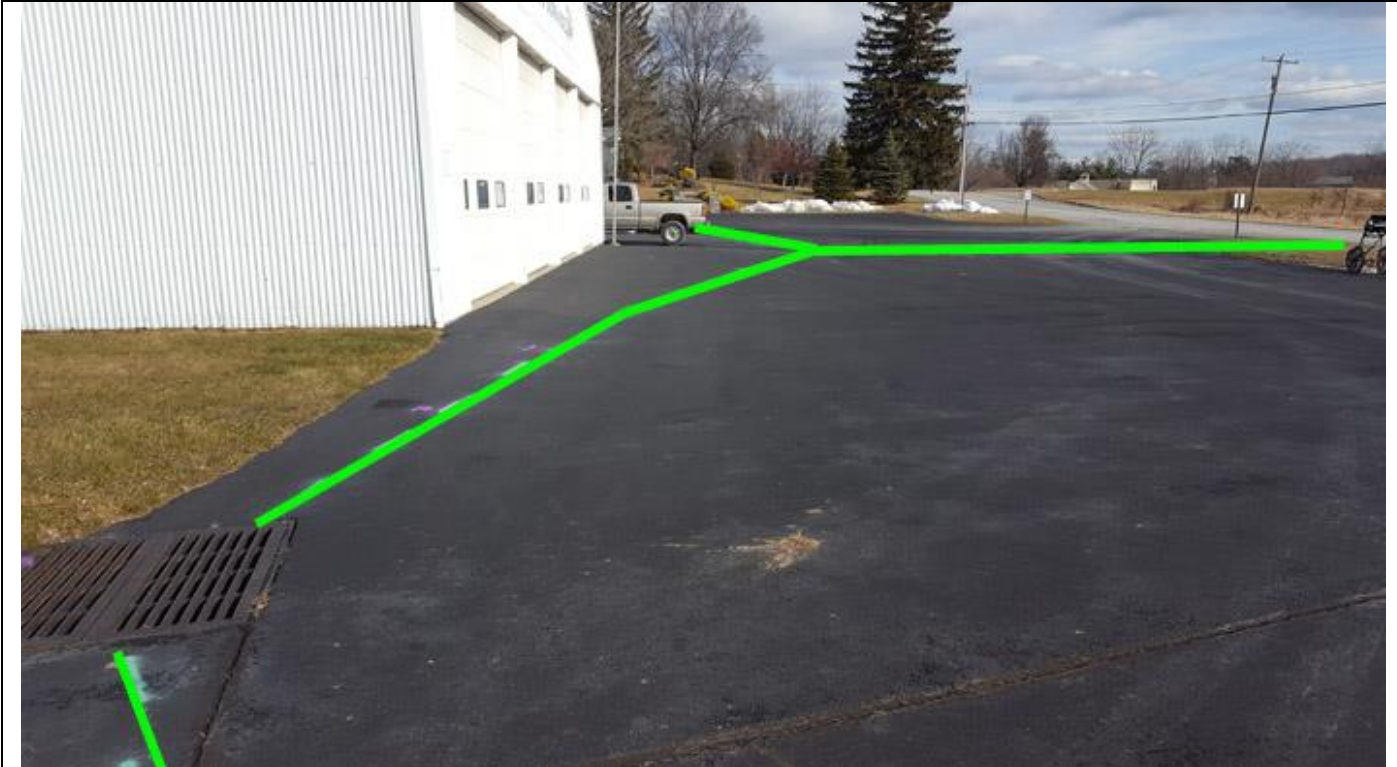
**PHOTO 13**

Northeast facing photo shows the storm sewer system beneath the asphalt. The sewers sit at depths of 3-4'.

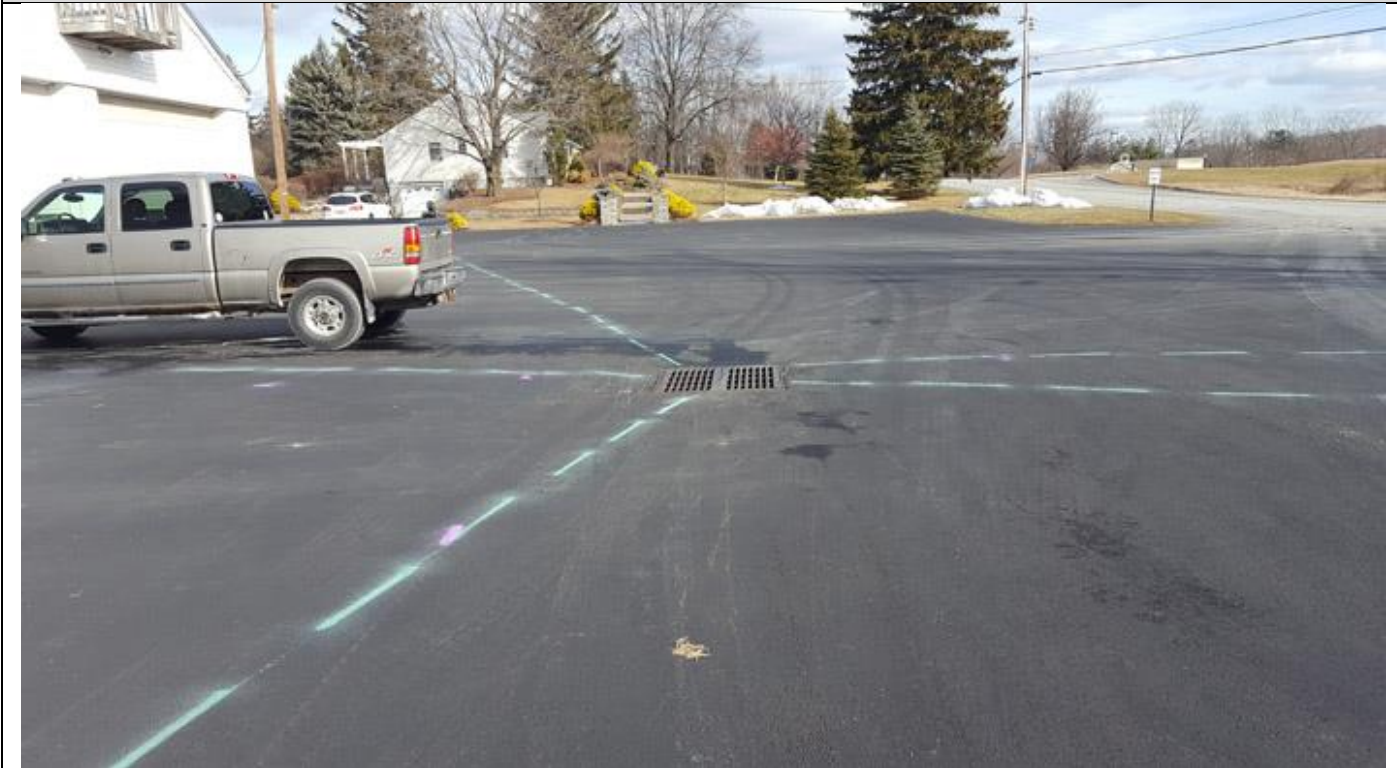
**PHOTO 14**

Northeast facing photo of the central sewer grate in front of the bus service building where five separate drains converge.

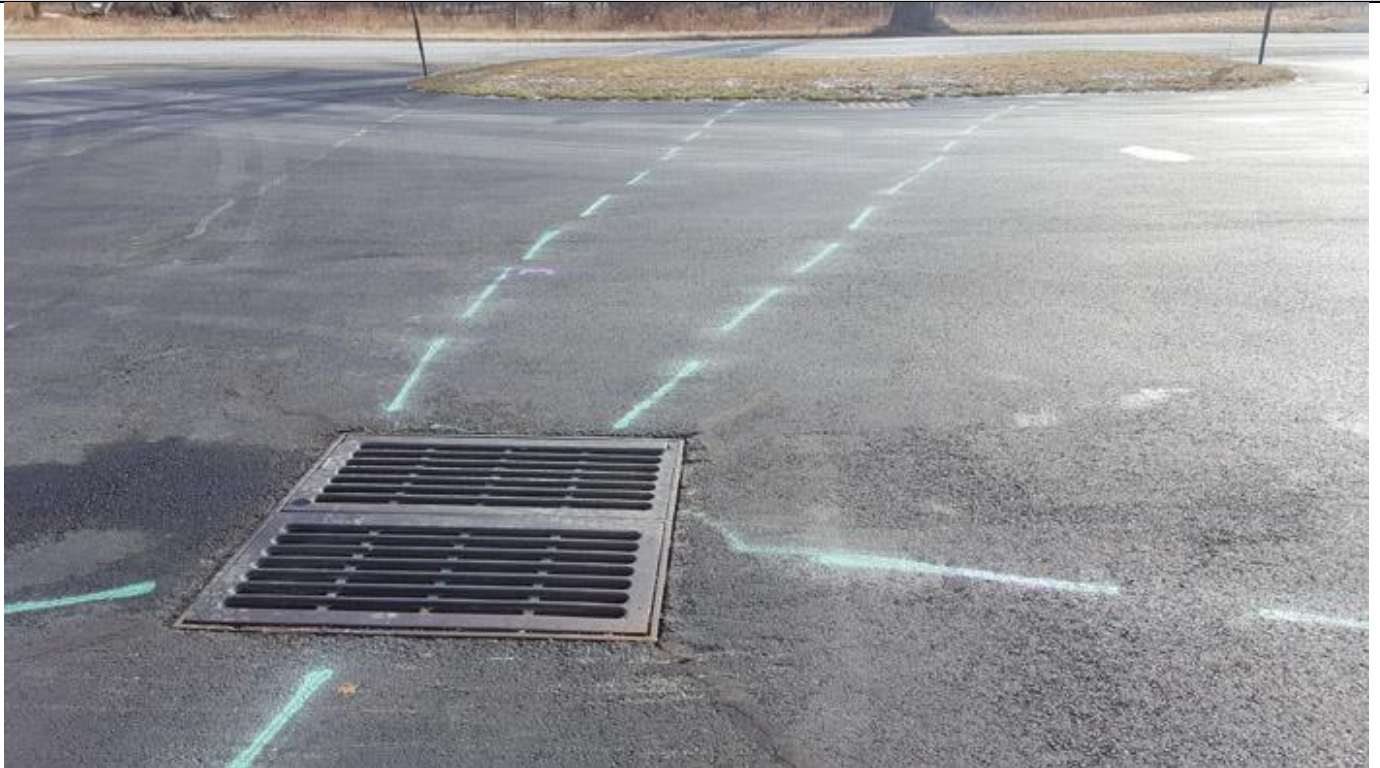
**PHOTO 15**

Southeast facing photo of the central sewer grate shown in Photo 14.

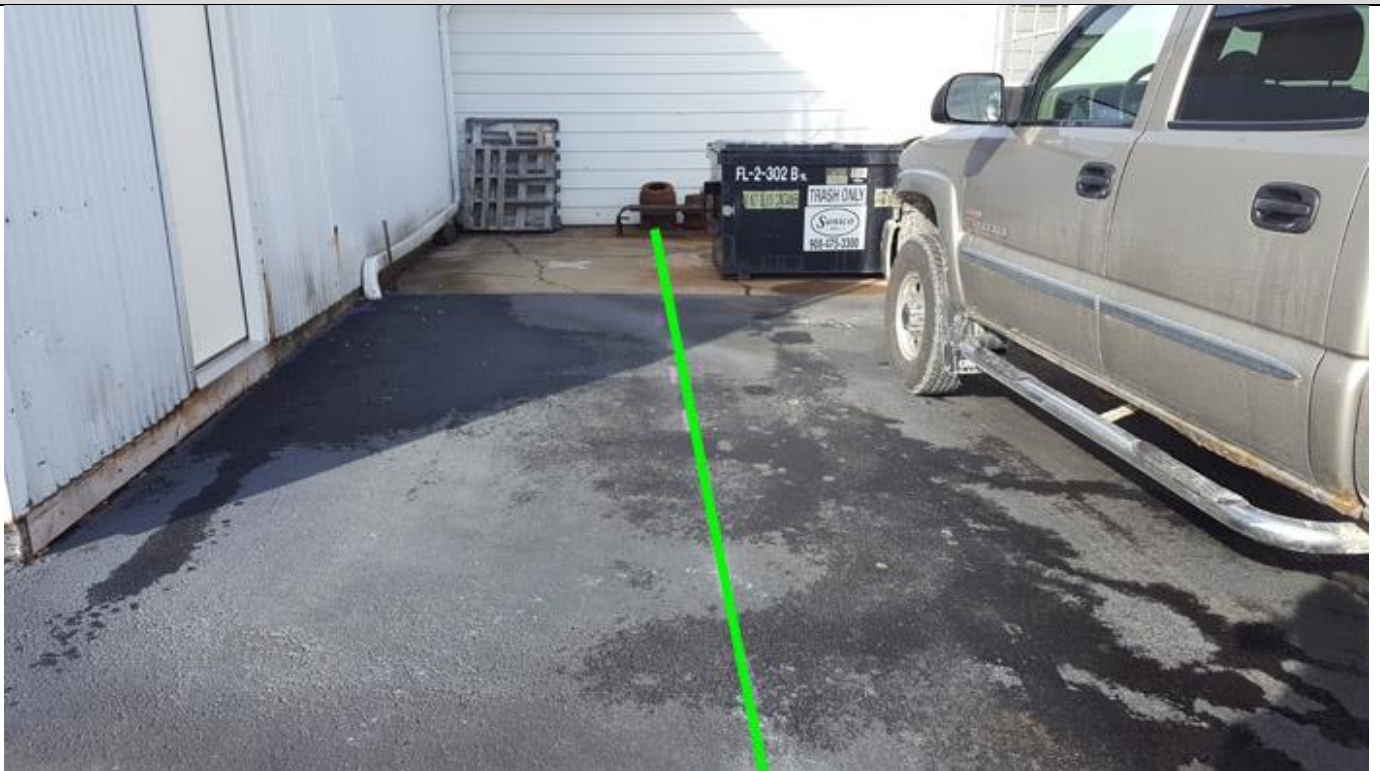
**PHOTO 16**

Northwest facing photo shows the storm sewer line which passes underneath the building and emerges on the back side.

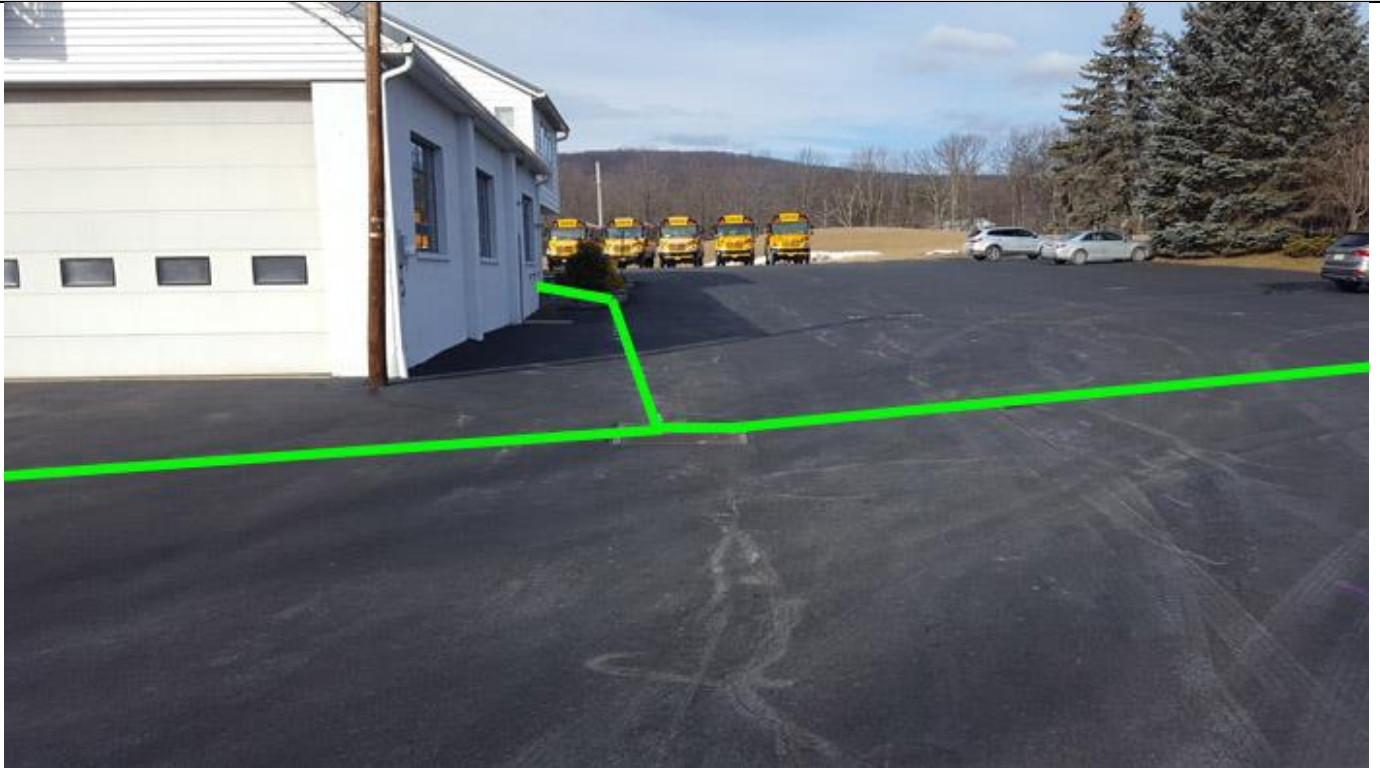
PHOTO 17

Northwest facing photo shows storm sewer lines.

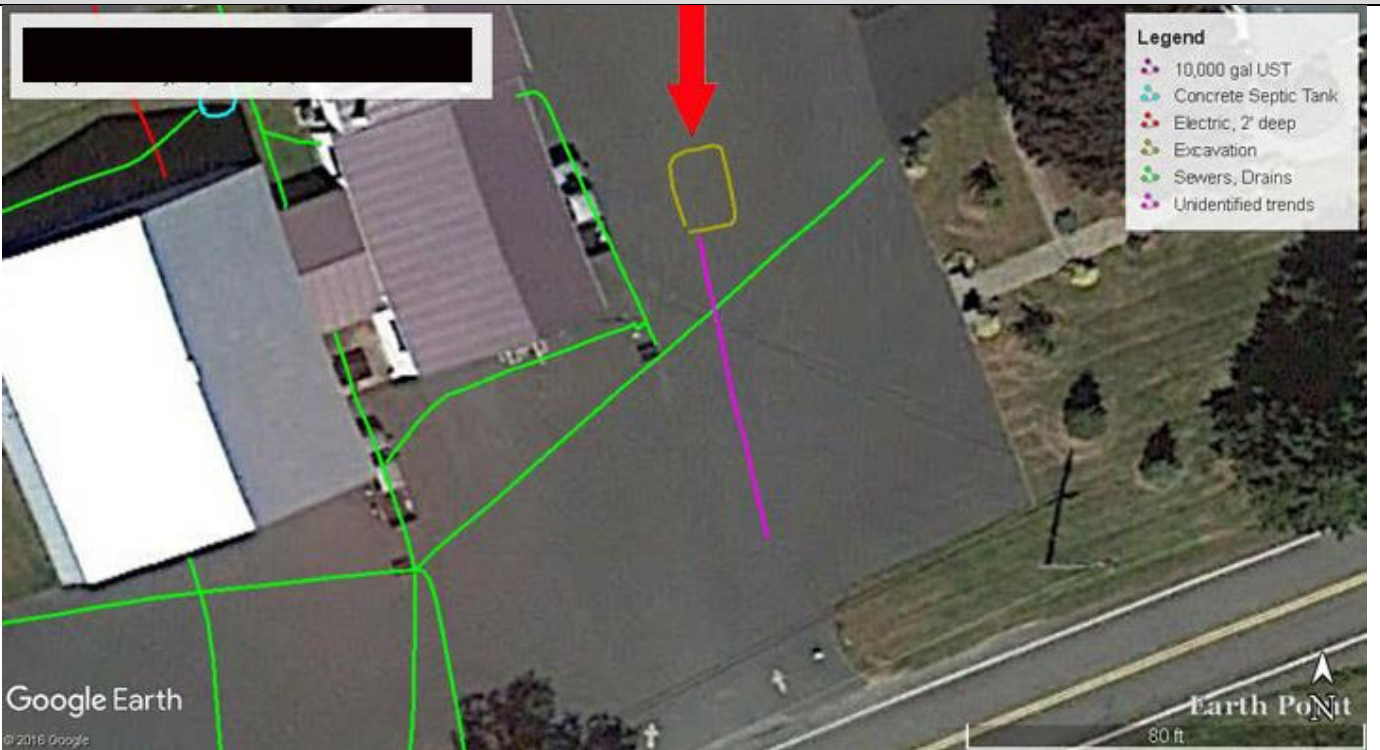
PHOTO 18

On the east side of the building there was a historic oil-water separator and a possible fuel UST, neither of which are still in place. One distinct excavation area was discovered measuring 13'x 10'. The excavation appeared to have steep sides with a strong reflection at 4' and a weak reflection at 2' possibly indicating clay layers associated with the filling of the excavation. A weak trend at a depth of 3' trends south from the excavation. This unidentified feature could be a pipe, possibly a clay pipe. The area to the southeast of the building was scanned with GPR in search of relics from a historic gas station, but no remains of this structure were found.

The red arrow indicates an area measuring 13' x 10' which is an apparent excavation area. The purple line trending south from the excavation is a weak unidentified trend at a depth of around 3'.

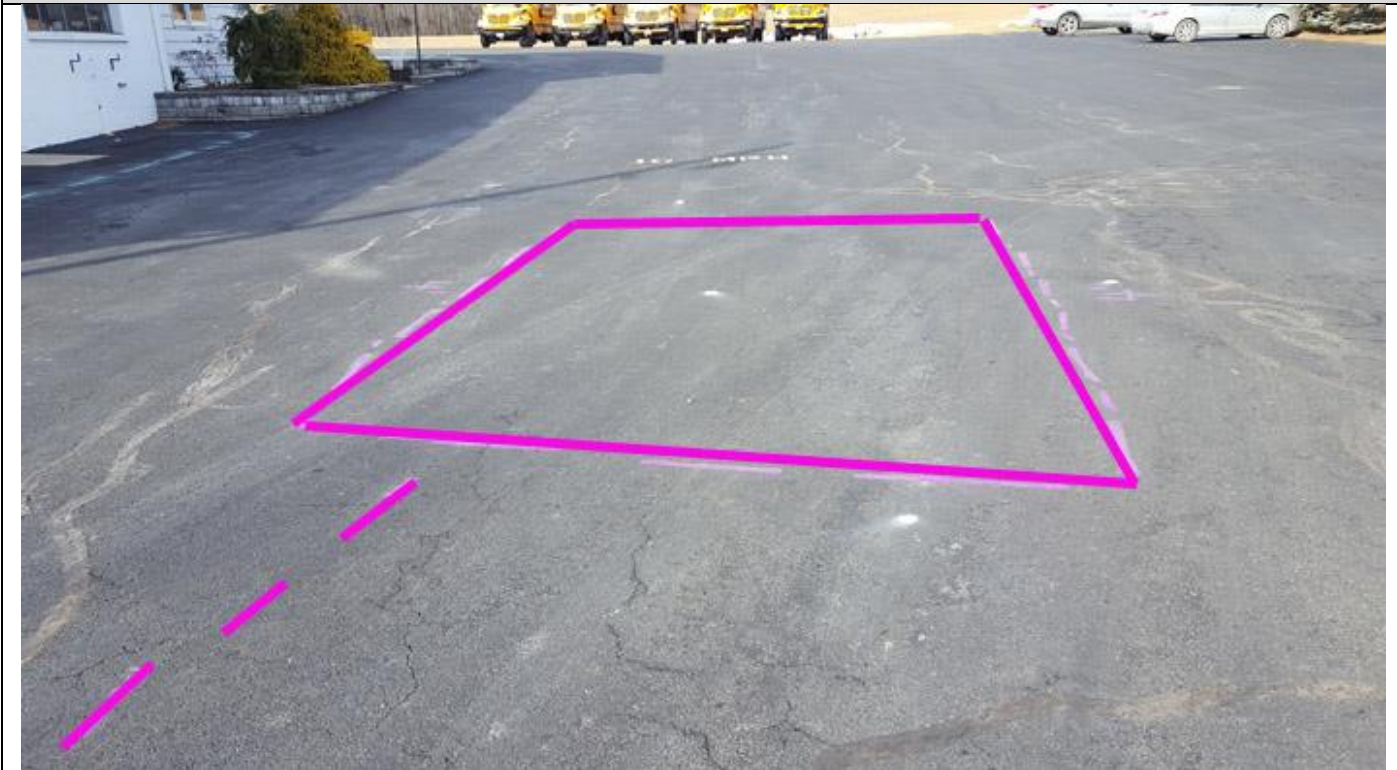
PHOTO 19

Northwest facing photo shows the apparent excavated area from Photo 18 as well as the unidentified trend leading south from that zone.

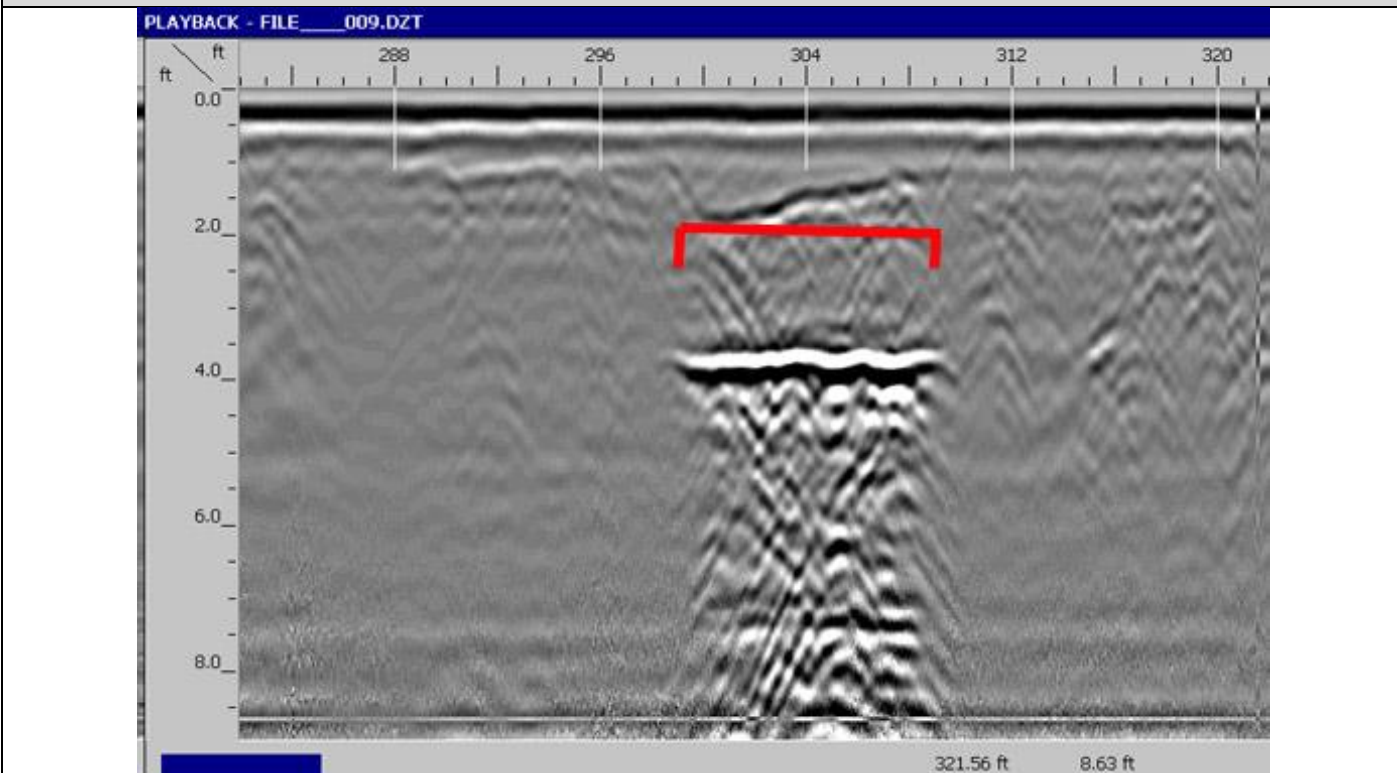
PHOTO 20

GPR transect across the apparent excavated area shows a strong reflection at a depth of 4' which may be a clay layer. A weaker reflection at around 2' may be an additional clay layer.
